THE PARKFIELD, CALIFORNIA, EARTHQUAKE
OF
JUNE 27, 1966

PRELIMINARY SEISMOLOGICAL REPORT

PRELIMINARY ENGINEERING SEISMOLOGICAL REPORT

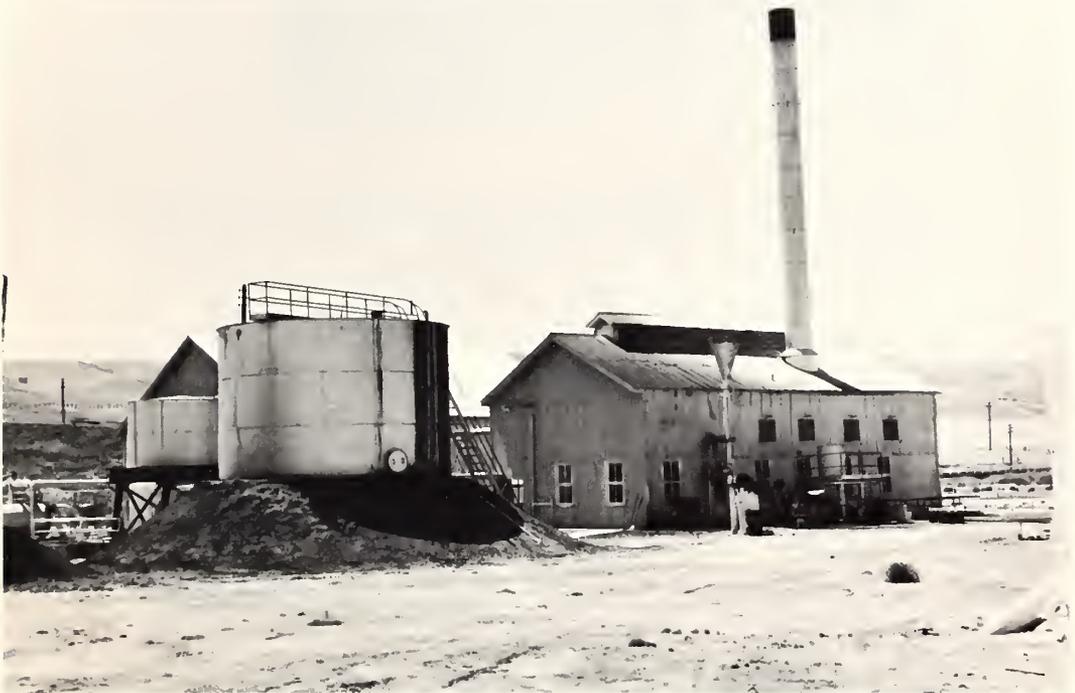
FIGURE 32.—Union Oil Co., Shandon Pumping Station. Strong-motion Station No. 6 is adjacent to pumping station. Note undamaged stack at right side of photo. (Photo by George Murray)

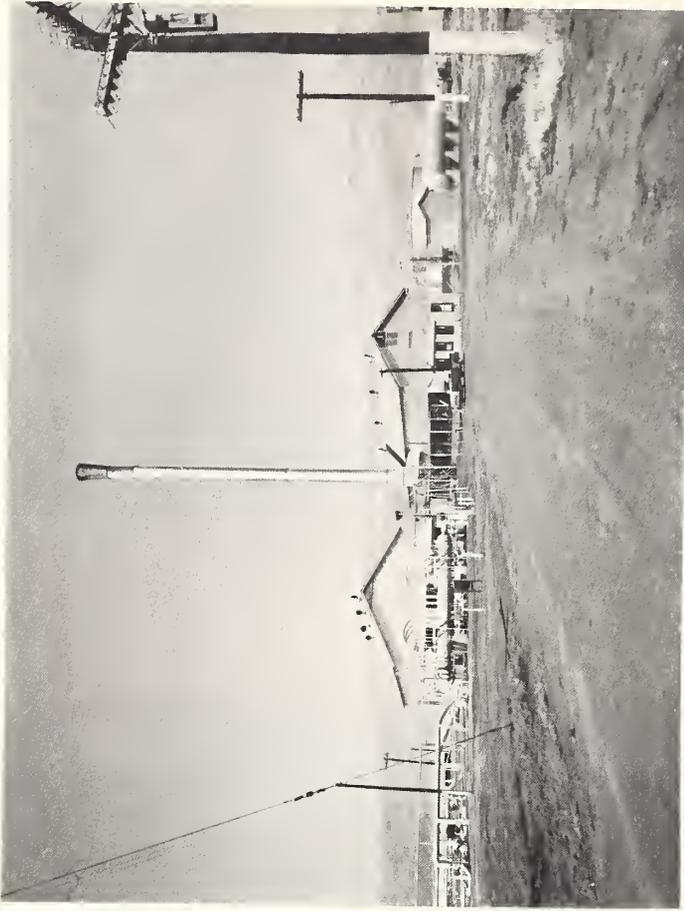
Shandon (northeast of; Strong-motion Station No. 8, Shandon Pumping Station).—Only damage was shifting of one of the eight boilers (fig. 34). The two southwest boilers were filled with water; the end boiler shifted southwest, probably ½ cm, forcing out caulking around the southwest boiler front. Water in each boiler was roughly estimated to be 350 bbl or about 11,000 gal. Mr. D. R. Imhoof reported one window broke and one cracked on south side of his wood-frame house. A mirror, 24 by 30

FIGURE 34.—Standard Pipeline Co., Shandon Pumping Station. Only damage reported was slight shifting toward southwest of one of the eight boilers. Note tall stack, at center of photo, that is still intact. Strong-motion Station No. 8 is adjacent to the pumping station. (Photo by George Murray)

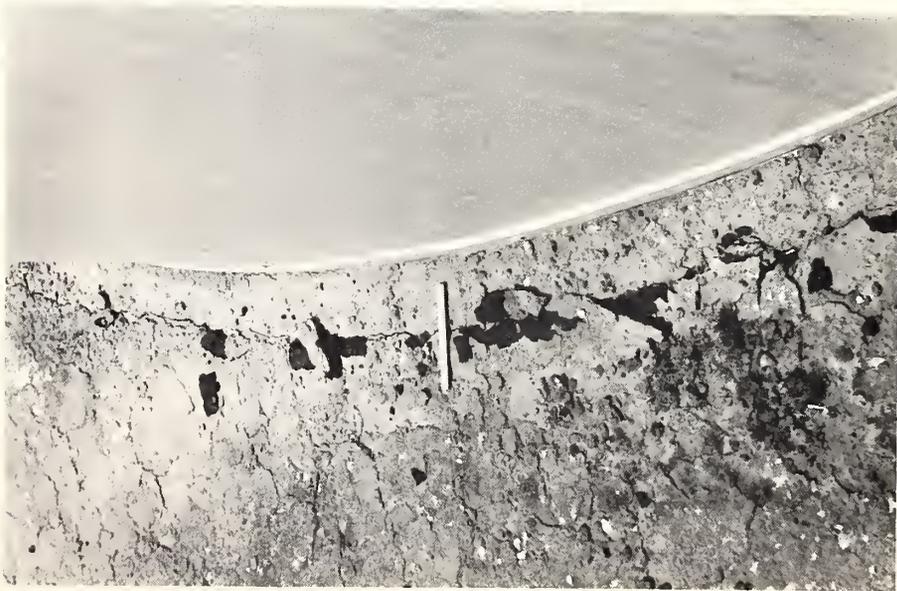
FIGURE 33.—Indication of earthquake-caused motion at base of tank in foreground of figure 32. (Photo by George Murray)

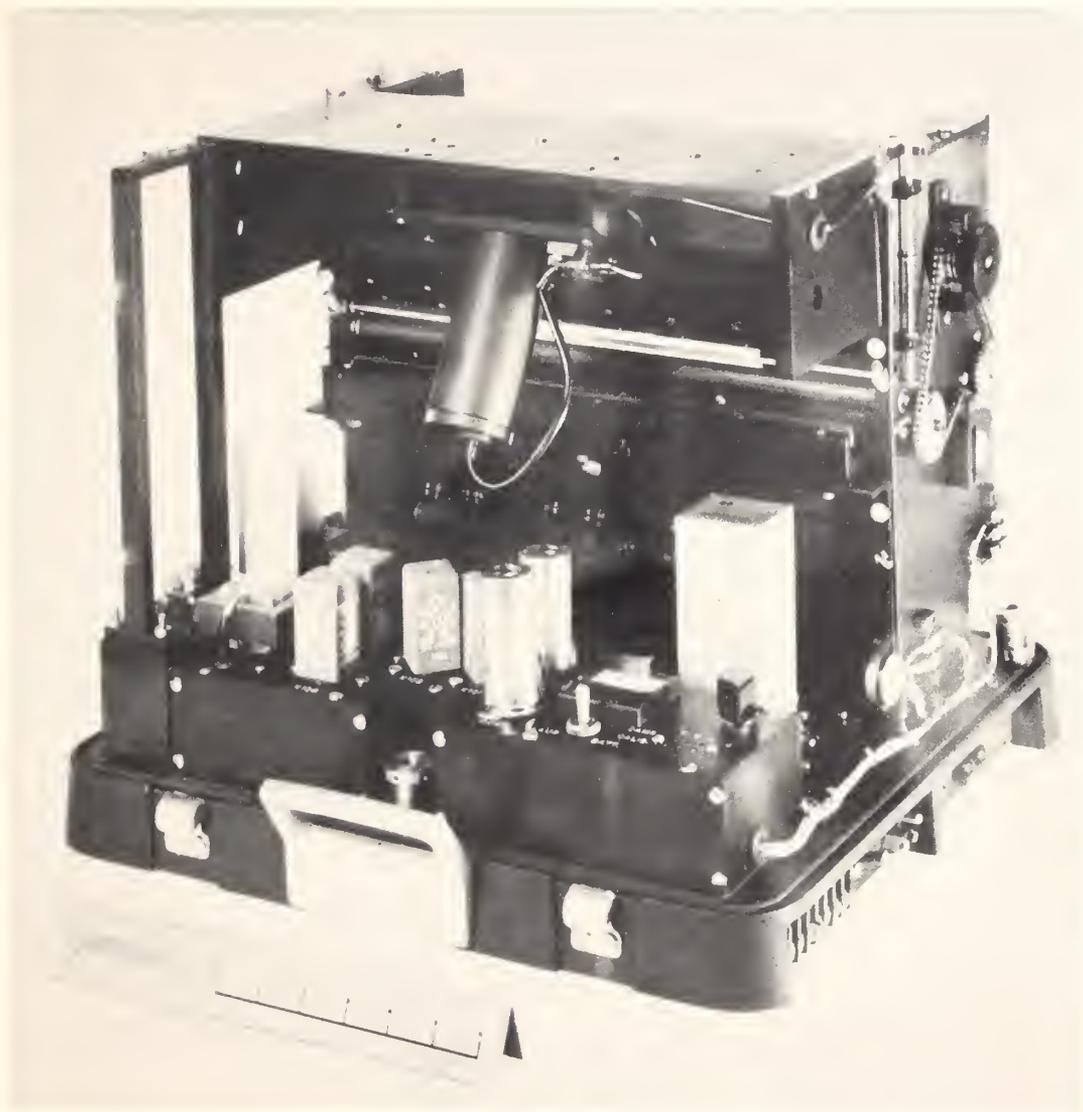
FIGURE 37.—AR-240 strong-motion accelerograph.

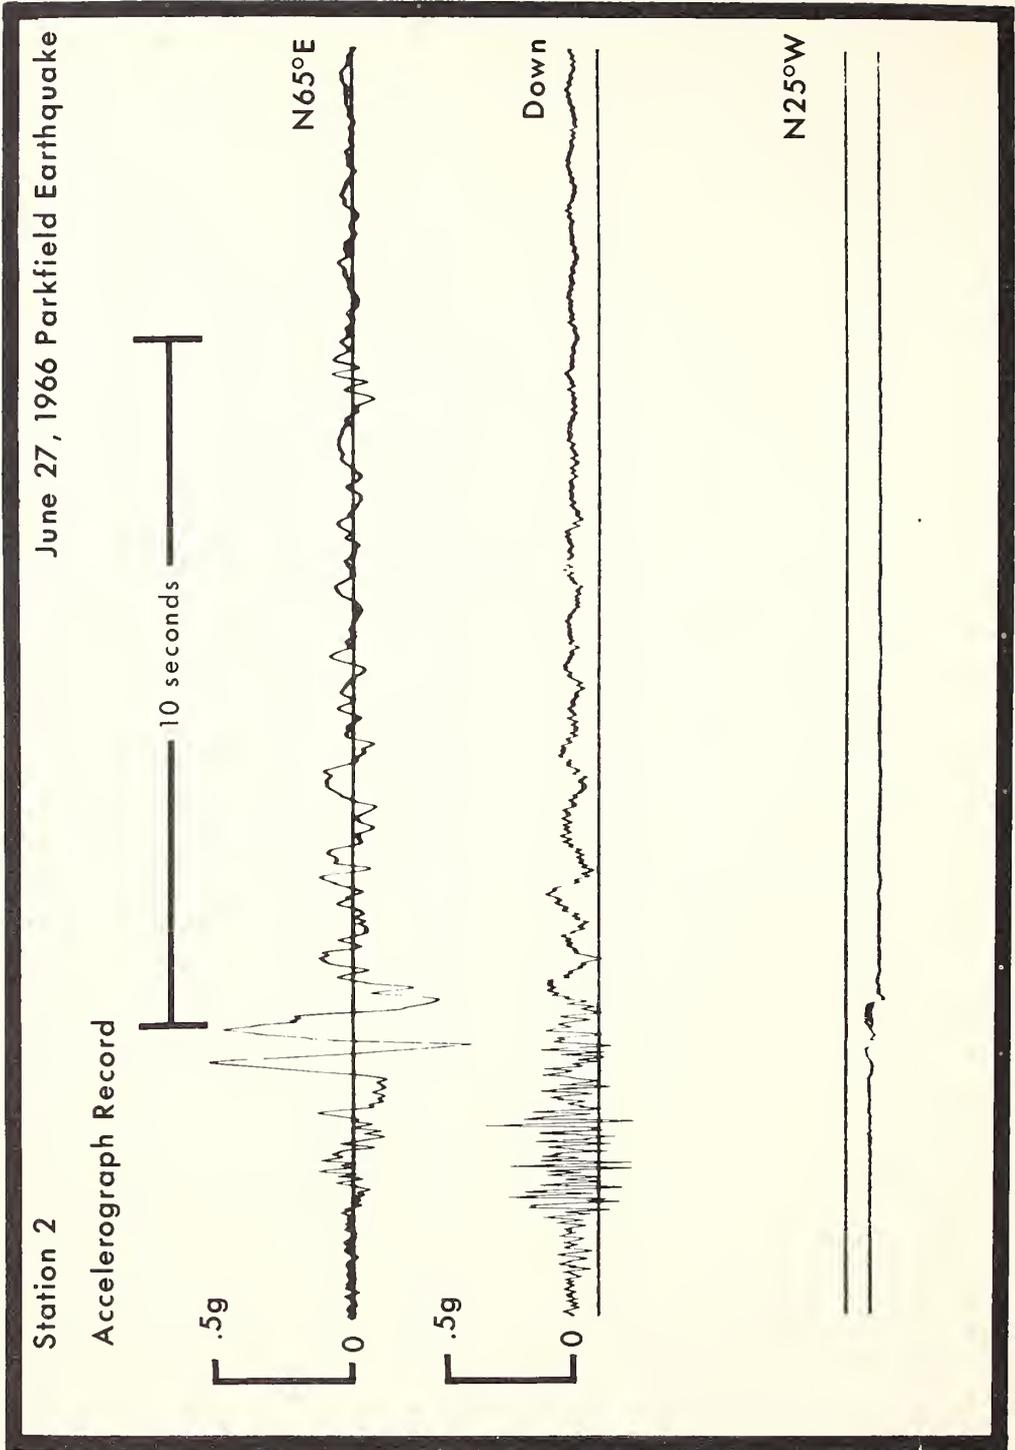
FIGURE 40.—Photocopy of Station 2 accelerogram. Pendulum recording lower N.25°W. Trace was not in operating condition during the earthquake.

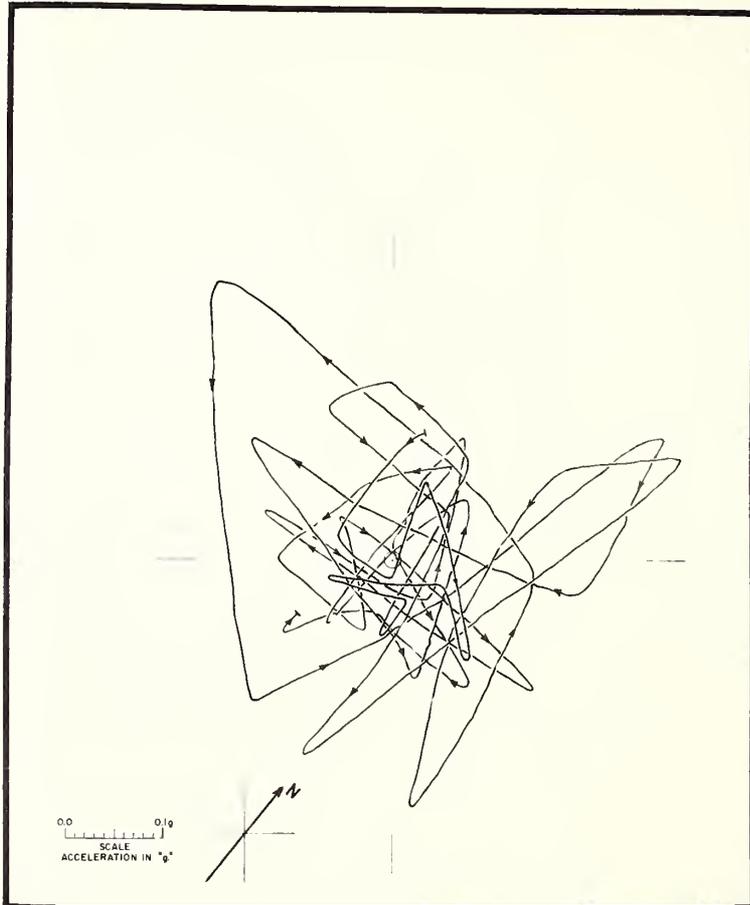
FIGURE 42.—Station 8. Resultant horizontal accelerations from 3.5 to 5.5 seconds after start of record.

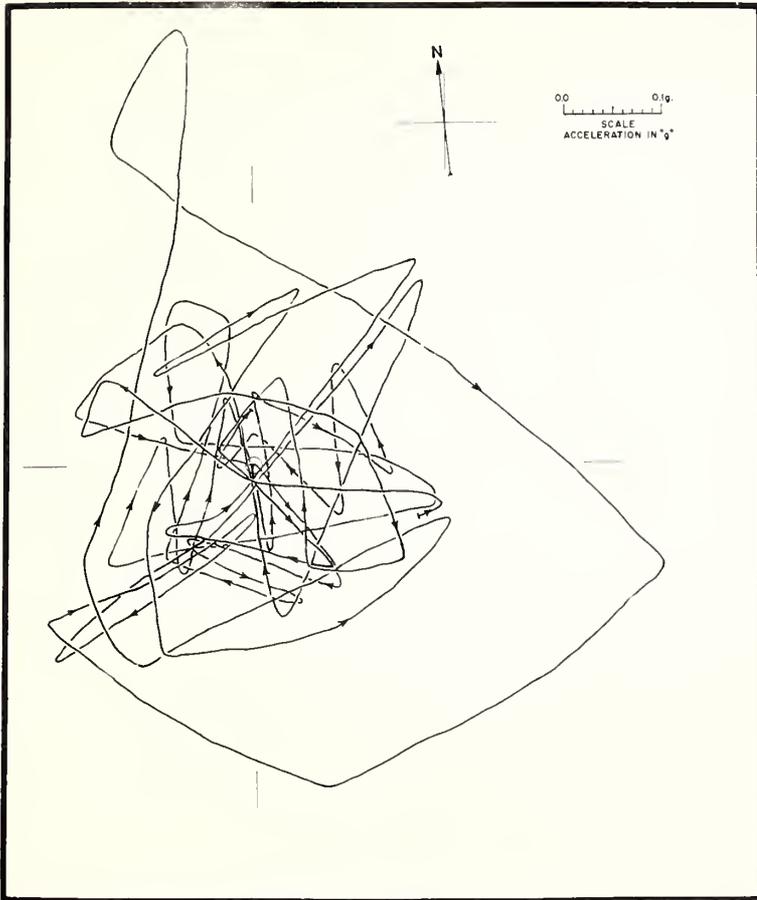
FIGURE 43.—Station 5. Resultant horizontal accelerations from 6.0 to 9.0 seconds after start of record.

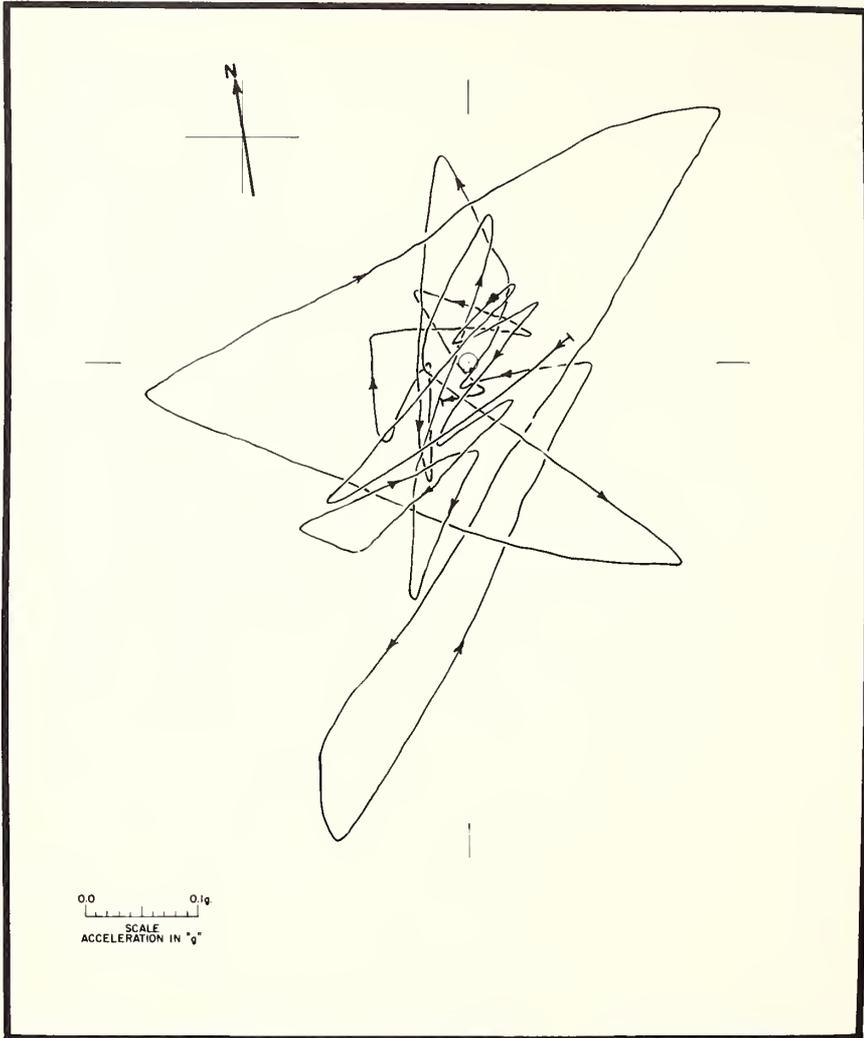
FIGURE 44.—Temblor Station. Resultant horizontal accelerations from 3.0 to 5.0 seconds after start of record.

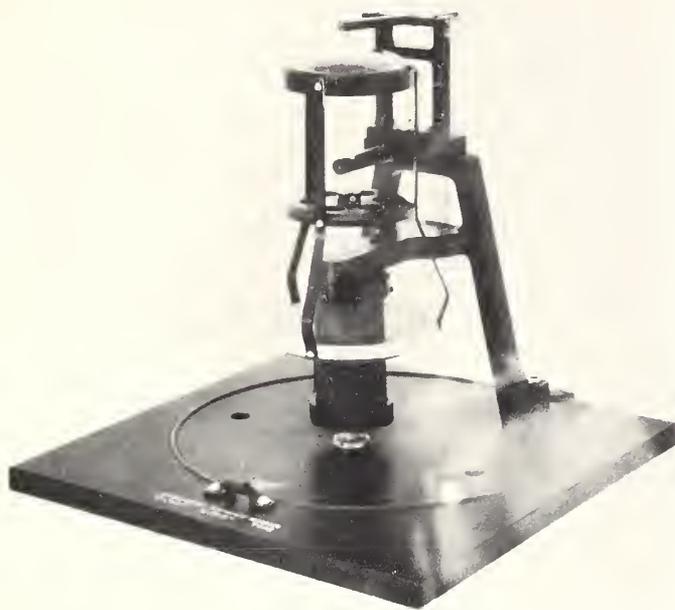
FIGURE 45.—*Coast and Geodetic Survey seismoscope.*

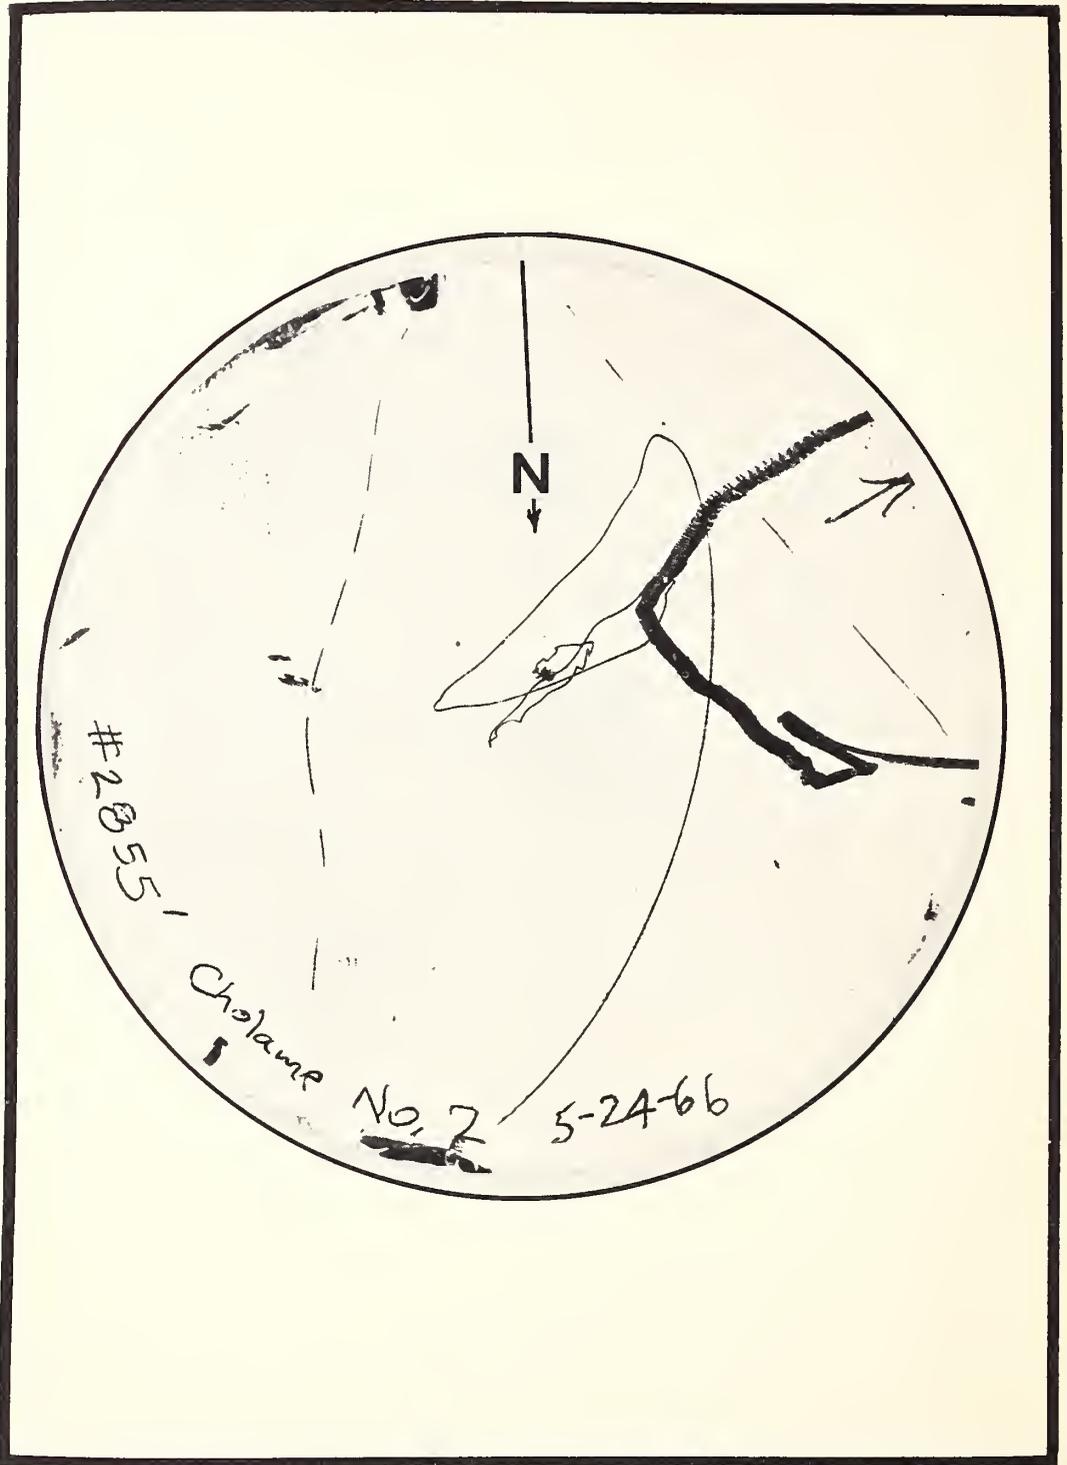
FIGURE 56.—Seismoscope record - Station 2. Glass record plate fell off instrument during main shock.
